The CVE-ID tracking this issue is: CVE-2020-3702

## **Description**

This advisory documents the impact of a vulnerability in the 2.4GHz radios of Arista Wireless Access Points (APs). Not all systems are impacted, please refer to the "Affected Platforms", and "Symptoms" sections below for specific required configuration to be vulnerable.

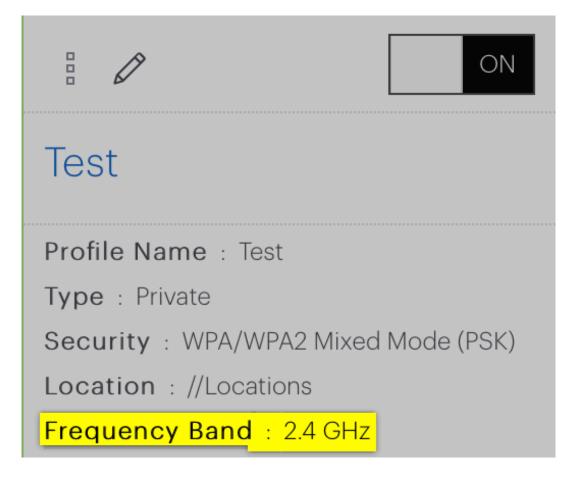
Example (GHz highlighted in yellow):

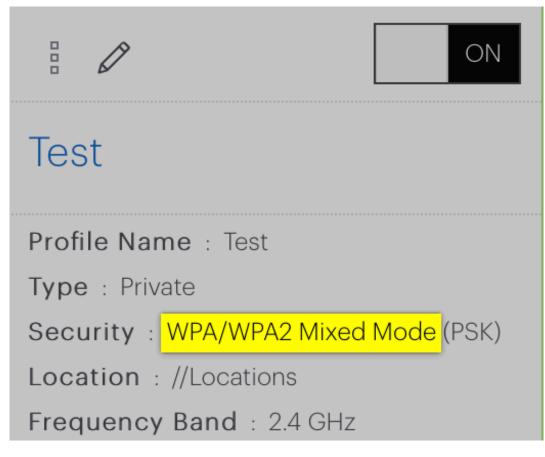
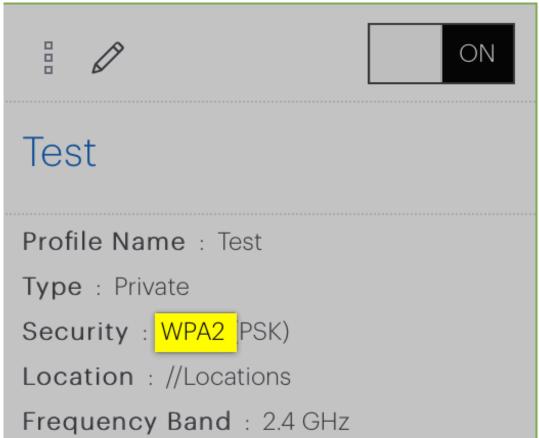
Note: As observed in the above examples, this vulnerability is applicable if either WPA2 mode or WPA/WPA2 mixed mode security standards are configured for the 2.4GHz SSID(s).
