Date:December 16th, 2020

The CVE-ID tracking this issue is: CVE-2020-3702

This advisory documents the impact of a vulnerability in the 2.4GHz radios of Arista Wireless Access Points (APs). Not all systems are impacted, please refer to the "Affected Platforms", and "Symptoms" sections below for specific required configuration to be vulnerable.

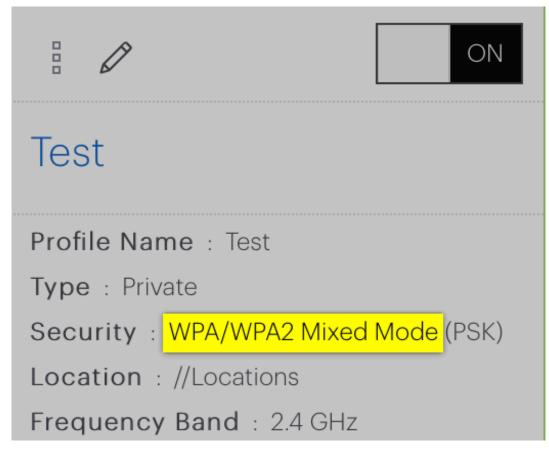
Note: As observed in the above examples, this vulnerability is applicable if either WPA2 mode or WPA/WPA2 mixed mode security standards are configured for the 2.4GHz SSID(s).
